Technical Report No.: 64.291.20.30219.01

Test subject: Product: Circular connectors
Type: MB03, MB04, MC04, MC05, MC08

Test specification: ISO 20653:2013, and client's requirements

This test report is for circular connectors and the items of IP69K carried out according to ISO 20653:2013 and the requirement of client.

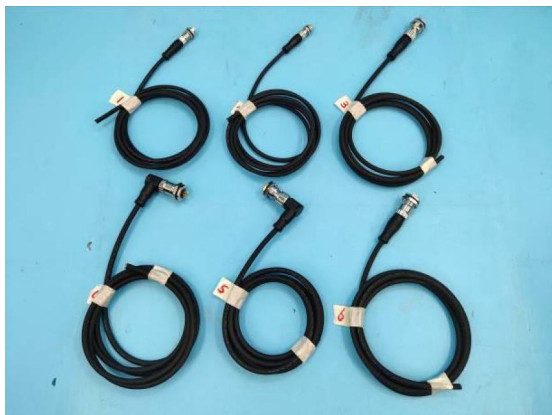
Before test

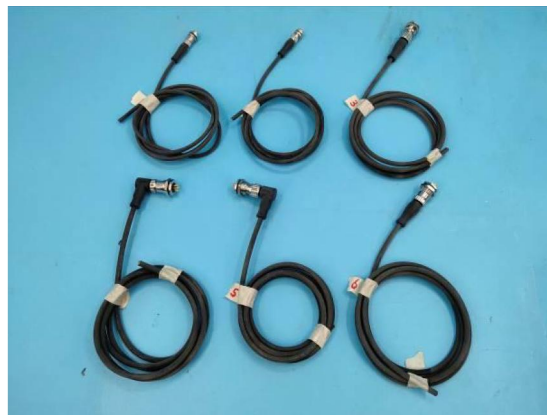
After test

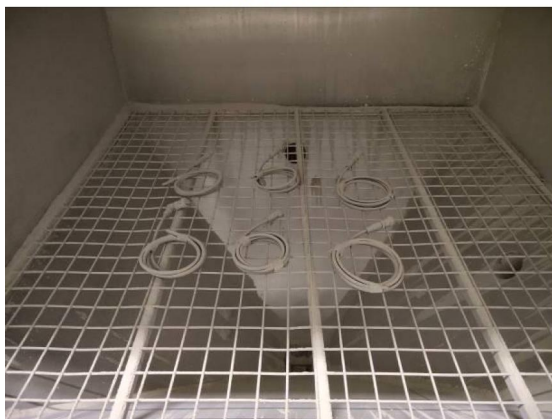
Test Setup

Test setup:

- 6 s movement of the air-dust mixture

- 15 min break

Test duration: 20 cycles

Dust: Arizona Test Dust

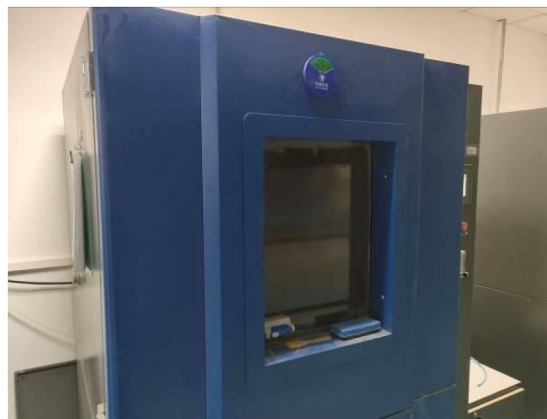
Overall layout

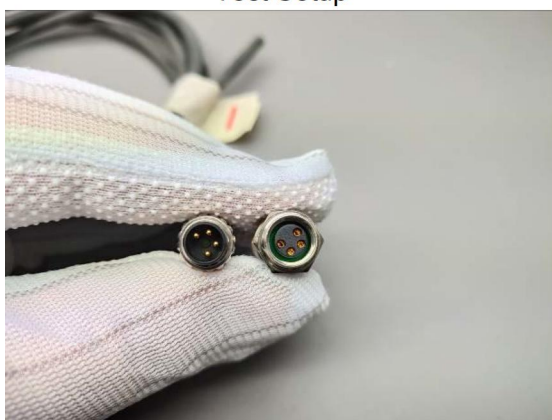
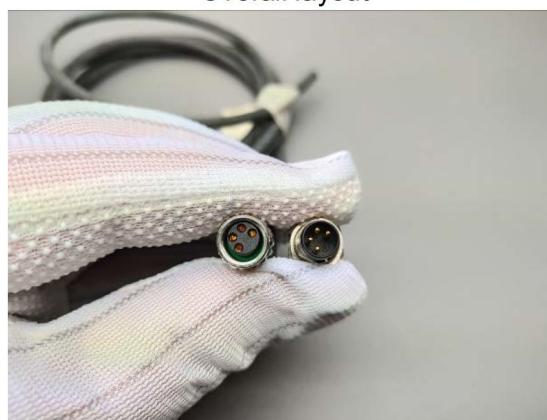
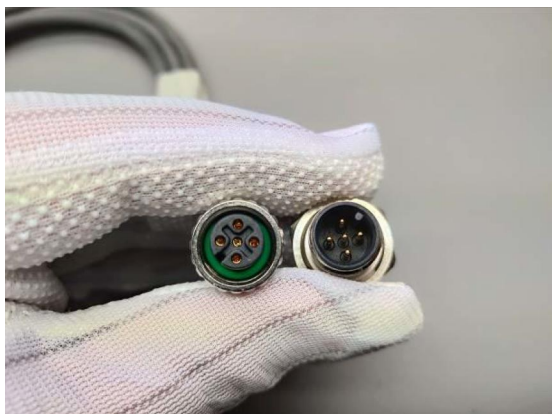
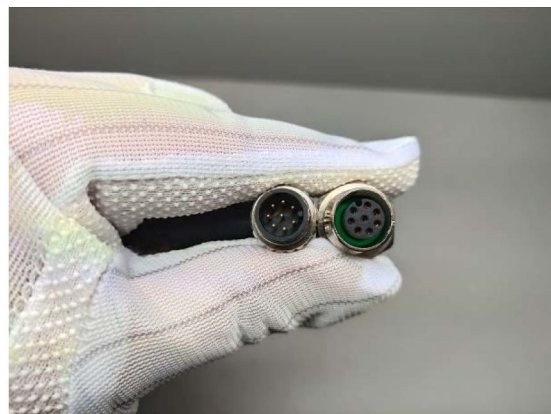
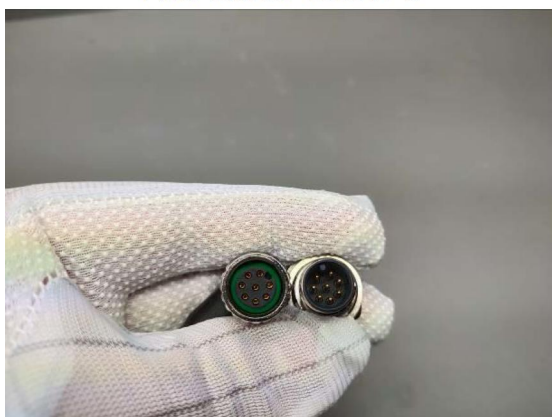
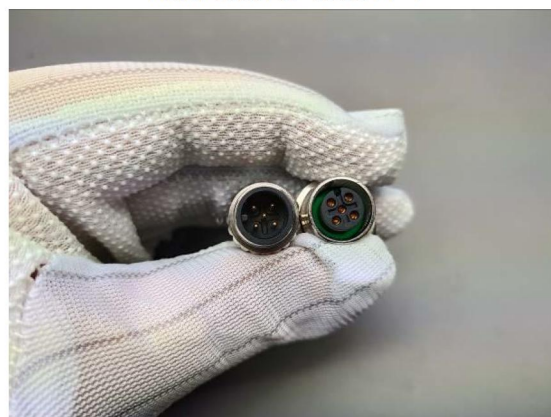
After test for 485811-1

After test for 485811-2

After test for 485811-3

After test for 485811-4

After test for 485811-5

After test for 485811-6

No.	Result	Verdict
485811-1	After test, no dust penetrates into the water-proof connector	Pass
485811-2	After test, no dust penetrates into the water-proof connector	Pass
485811-3	After test, no dust penetrates into the water-proof connector	Pass
485811-4	After test, no dust penetrates into the water-proof connector	Pass
485811-5	After test, no dust penetrates into the water-proof connector	Pass
485811-6	After test, no dust penetrates into the water-proof connector	Pass

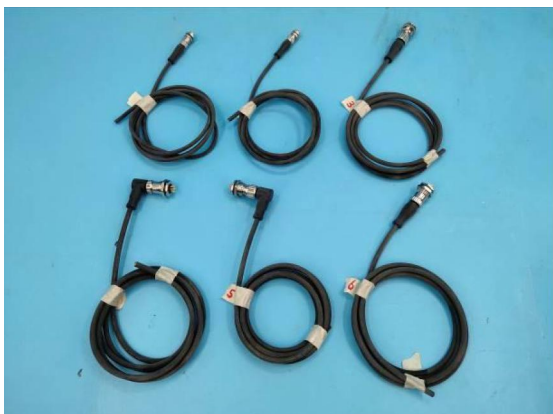
Before test-

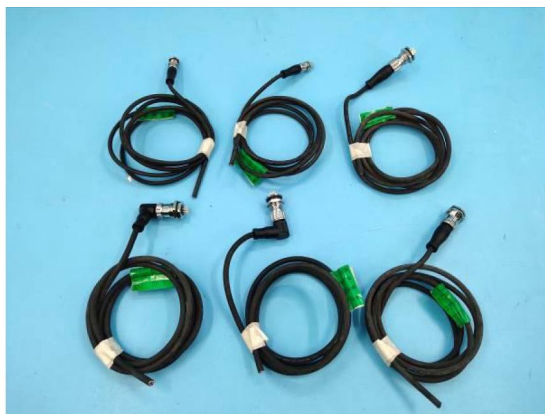
After test-

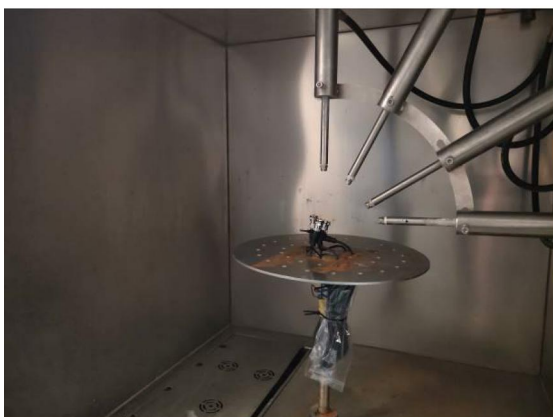
Test Setup

Mount sensors (with mating connector installed) on a testing fixture. The test shall be performed with the water directed at high pressure against the connector assembly at the following conditions:

Spray amount: 14 up to 16 l/m.

Water pressure of 100 bar, at a temperature of 176 °F for 30s per position for a total of 120 s without water ingress.

Sensor on a rotating table (5 revolutions per minute).

Angle of the water spray: 0°, 30°, 60° and 90°.

Distance nozzle to sensor of 10 to 15 cm (3.94 to 5.9 inches).

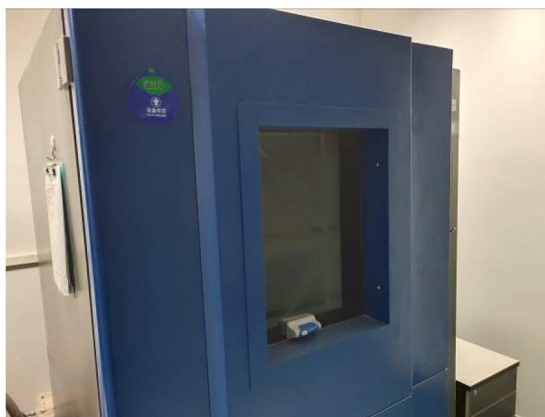
Overall layout

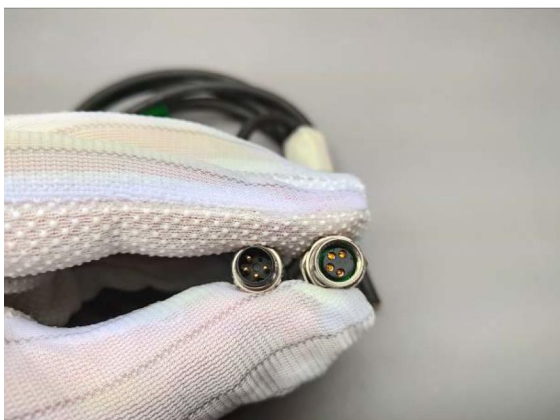
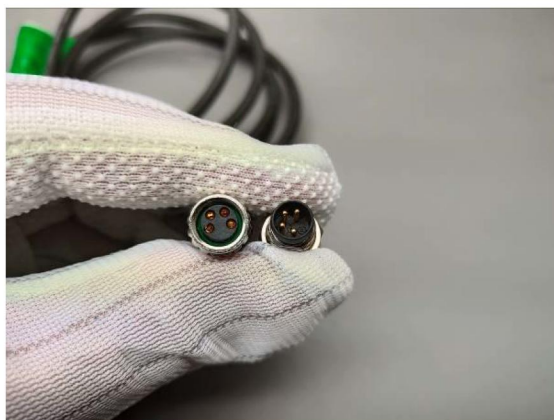
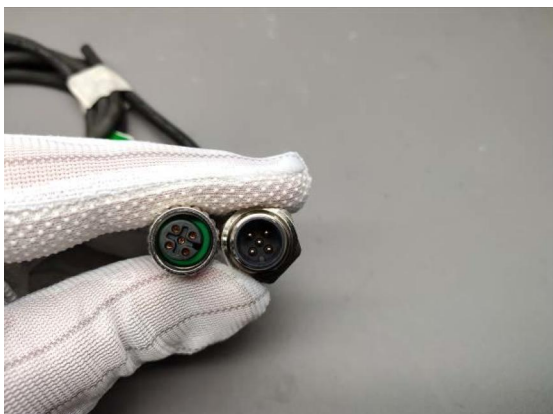
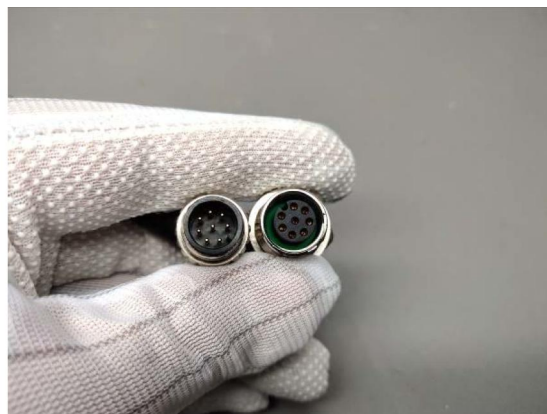
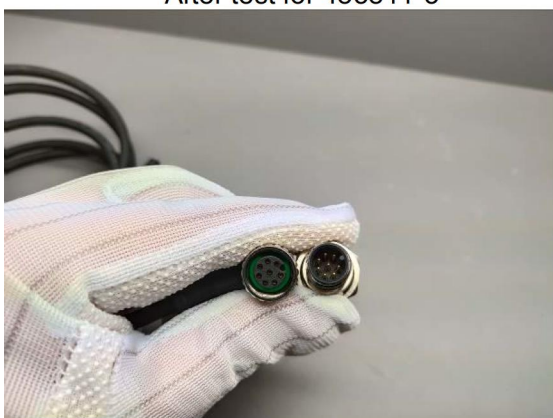
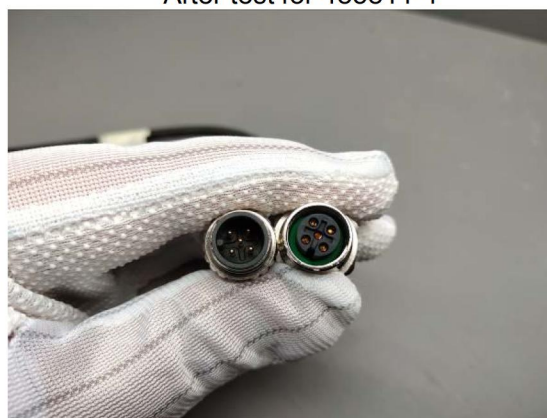
After test for 485811-1

After test for 485811-2

After test for 485811-3

After test for 485811-4

After test for 485811-5

After test for 485811-6

No.	Result	Verdict
485811-1	After test, no water ingress into the sample, and no swelling of plastics.	Pass
485811-2	After test, no water ingress into the sample, and no swelling of plastics.	Pass
485811-3	After test, no water ingress into the sample, and no swelling of plastics.	Pass
485811-4	After test, no water ingress into the sample, and no swelling of plastics.	Pass
485811-5	After test, no water ingress into the sample, and no swelling of plastics.	Pass
485811-6	After test, no water ingress into the sample, and no swelling of plastics.	Pass
