Test Report

Report No.: EED31I00484801R1

Sample Name : M12 Panel Connectors
 Model : MC05PXXXX series, MC03PXXXX series, MC04PXXXX series, MC08PXXXX series, MC12PXXXX series
 Trade : Cableforce
 Test Item : IP67
 Surrounding : 24°C, 61%R.H.
 State of Sample(s) : Normal
 Sample Quantity : 1 pc
 Manufacture : Cableforce Electronics Company Limited

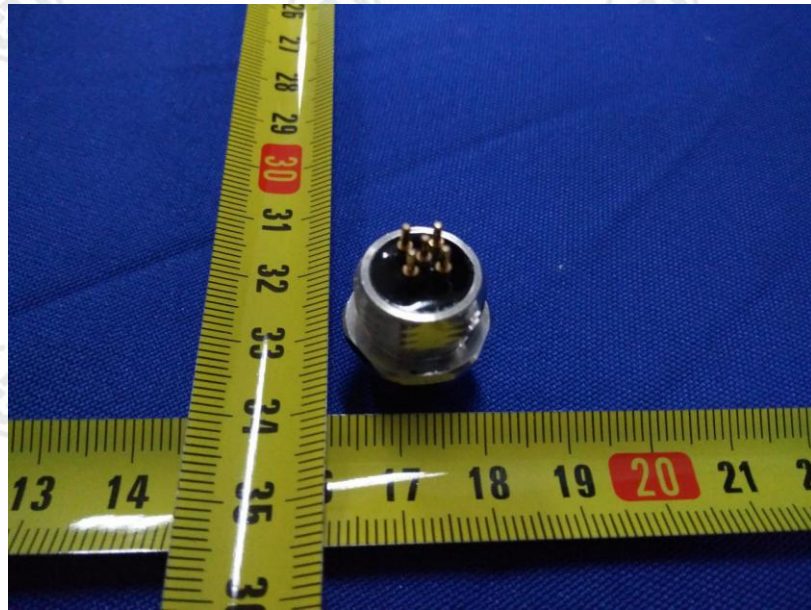
Fig.1- Overall view of model MC05P4LPG3AB

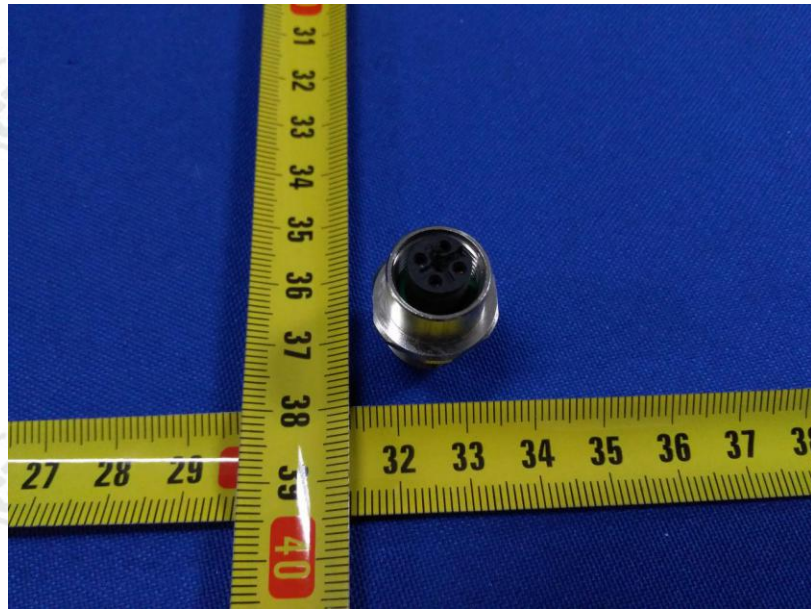
Fig.3- Overall view of model MC05P4LPG3AB

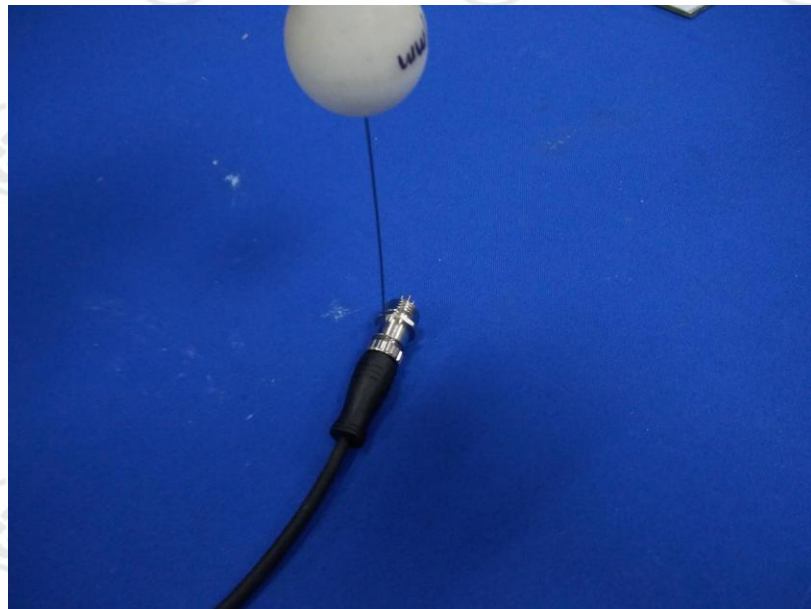
Fig.4- Sample during IP6X test(using test wire of 1.0mm Φ)

- 1) The test wire of 1.0mm Φ shall not penetrate and adequate clearance shall be kept.
- 2) The test is made using a dust chamber, the powder circulation pump may be replaced by other means suitable to maintain the talcum powder in suspension in a closed test chamber. The talcum powder used shall be able to pass through a square-meshed sieve the nominal wire diameter of which is 50 μm and the nominal width of a gap between wires 75 μm . The amount of talcum powder to be used is 2 Kg per cubic meter of the test chamber volume. It shall not have used for more than 20 tests.
- 3) If an extraction rate of 40 to 60 volumes per hour is obtained the duration of the test is 2 h.
- 4) If, with a maximum depression of 2 kPa(20 mbar), the extraction rate is less than 40 volumes per hour, the test is continued until 80 volumes have been drawn through, or a period of 8 h has elapsed.

Sample No.	Test time	Observations	Verdict
S161014003-1	2h	The test wire did not penetrate the specimens, and adequate clearance was kept. After test, no deposit of talcum powder entered in enclosure.	Pass

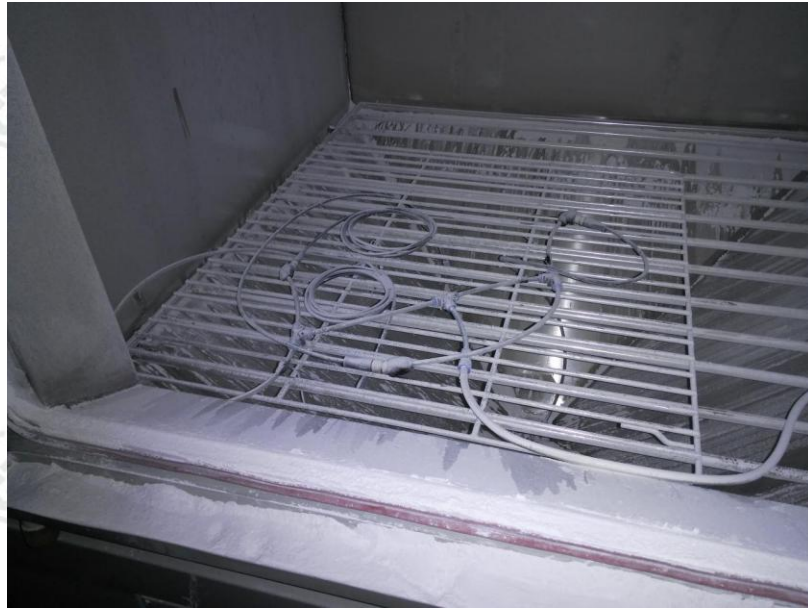
Fig.5- Sample during IP6X test

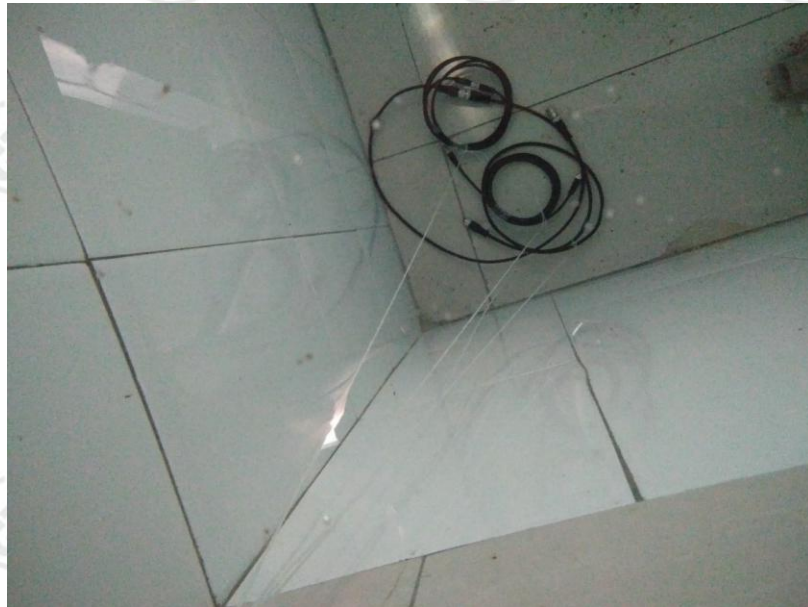
Fig.6- Sample during IPX7 test

- 1) The lowest point of enclosures with a height less than 850 mm is located 1000 mm below the surface of the water.
- 2) The duration of the test is 30 min.
- 3) The water temperature does not differ from that of the equipment by more than 5 K. However, a modified requirement may be specified in the relevant product standard if the tests are to be made when the equipment is energized and/or its parts in motion.

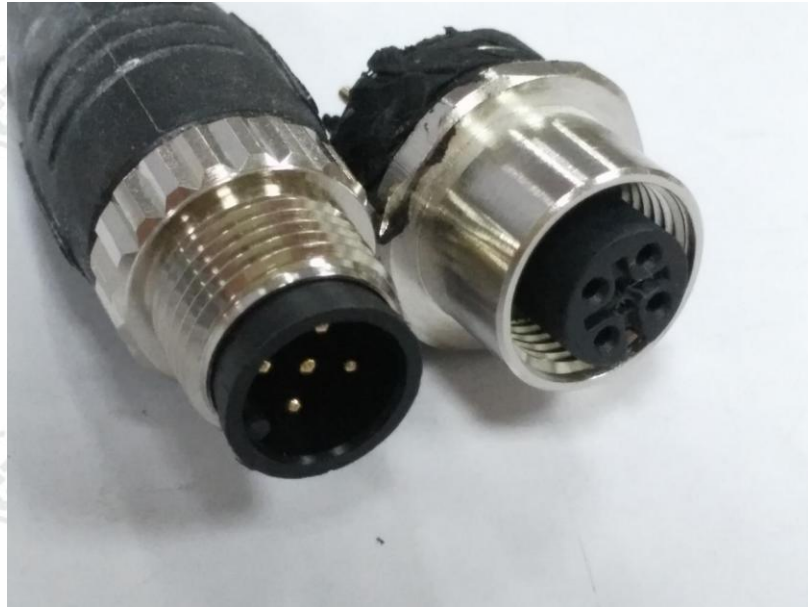
Fig.7- Sample after IP6X test

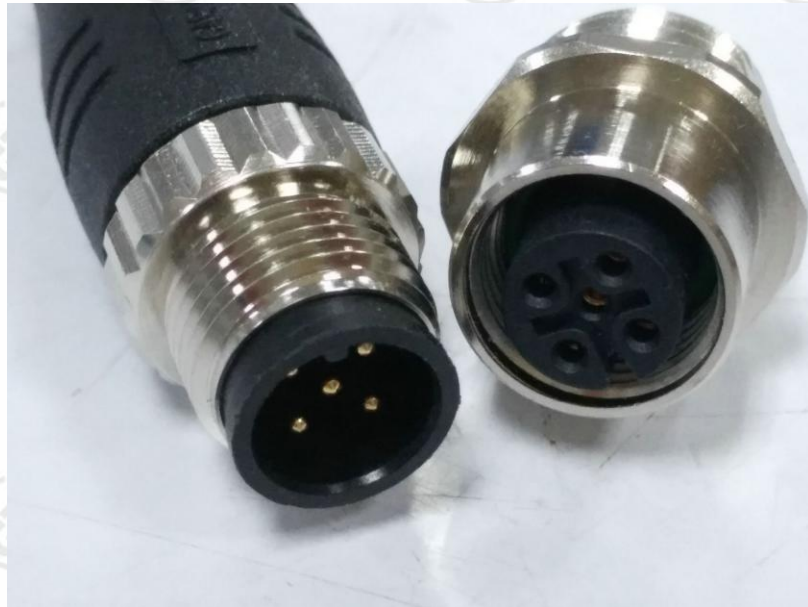
Fig.8- Sample after IPX7 test

Sample No.	Test time	Observations	Verdict
S161014003-1	30min	After the test, no trace of water entered in enclosure.	Pass

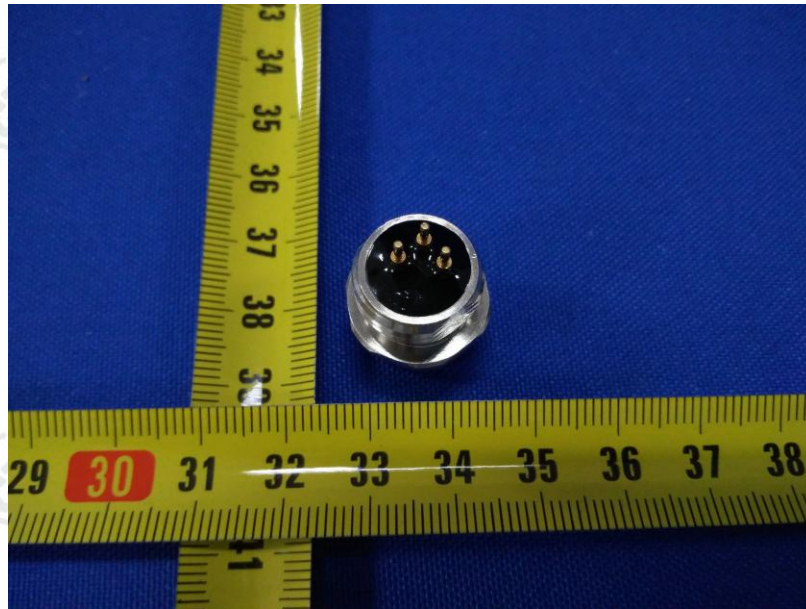
Fig.9- Overall view of model MC03PXXXX series

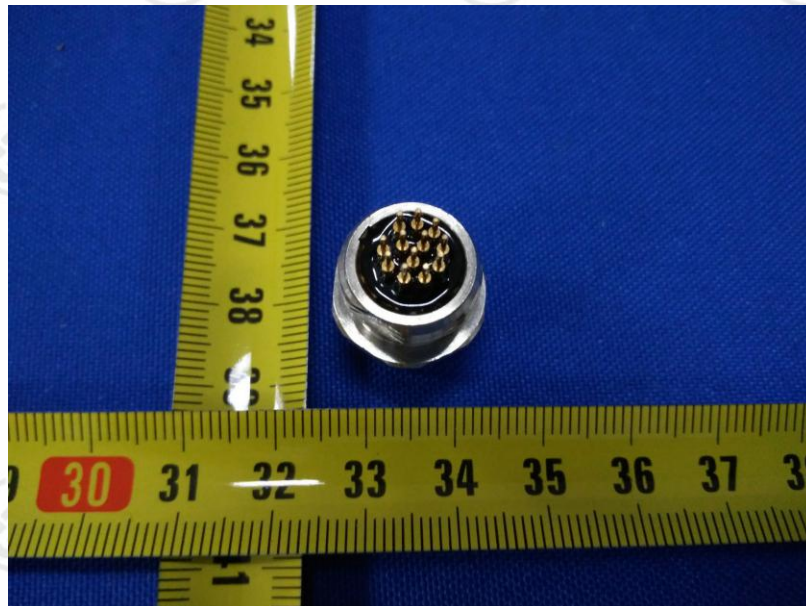
Fig.12- Overall view of model MC12PXXXX series
