# Test Report

Report No.: EED31I00484804R1

Sample Name : M8 Circular Connectors and M8 Cable  
Model : MB04CXXXX series, MB03CXXXX series, MB05CXXXX series, MB06CXXXX series, MB08CXXXX series  
Trade : Cableforce  
Test Item : IP67  
Surrounding : 24°C, 61 %R.H.  
State of Sample(s) : Normal  
Sample Quantity : 1 pc  
Manufacture : Cableforce Electronics Company Limited

Sample Received Date : Oct. 17, 2016  
Sample tested Date : Oct. 19, 2016  
Test Requested : 1) IEC 60529:2013;  
2) According to client's request.

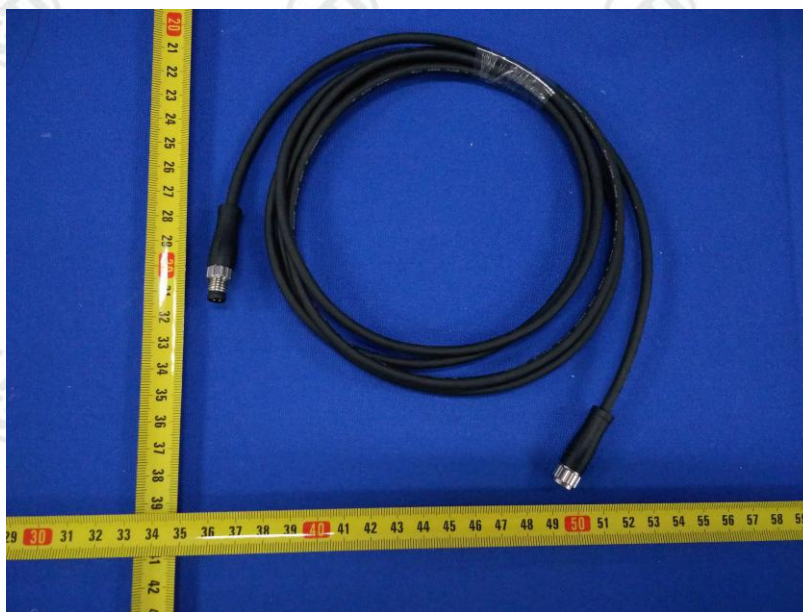
Fig.1- Overall view of model MB04C3LSG3AB

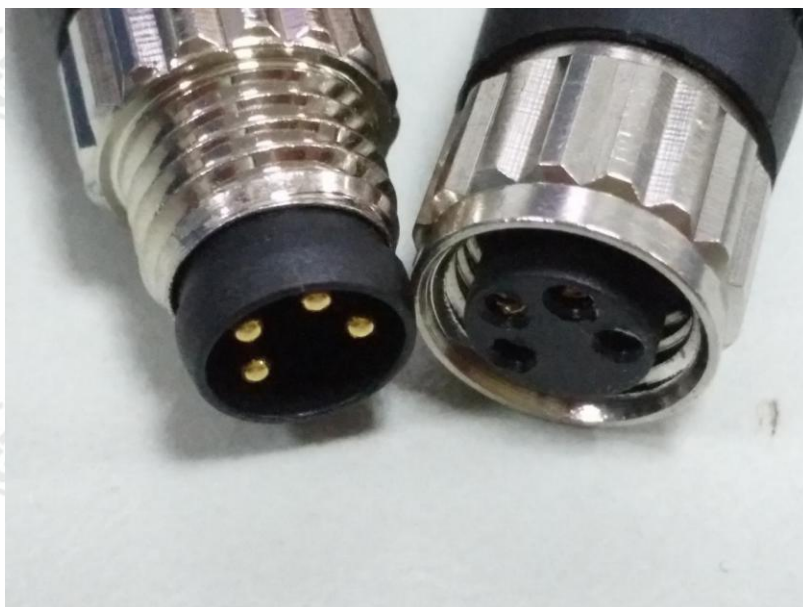
Fig.2- Overall view of model MB04C3LSG3AB

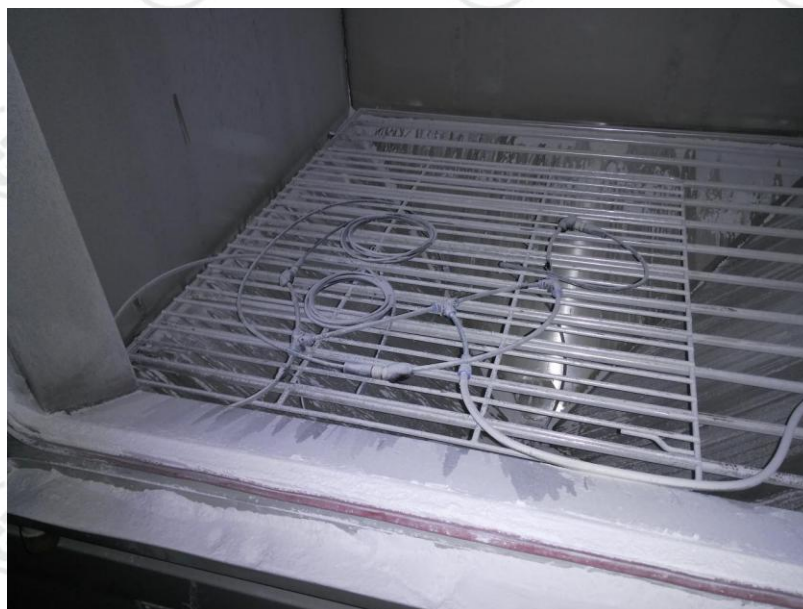
Fig.4- Sample during IP6X test

- 1) The test wire of 1.0mm  $\Phi$  shall not penetrate and adequate clearance shall be kept.
- 2) The test is made using a dust chamber, the powder circulation pump may be replaced by other means suitable to maintain the talcum powder in suspension in a closed test chamber. The talcum powder used shall be able to pass through a square-meshed sieve the nominal wire diameter of which is 50  $\mu\text{m}$  and the nominal width of a gap between wires 75  $\mu\text{m}$ . The amount of talcum powder to be used is 2 Kg per cubic meter of the test chamber volume. It shall not have used for more than 20 tests.

Sample No.	Test time	Observations	Verdict
S161014003-4	2h	The test wire did not penetrate the specimens, and adequate clearance was kept. After test, no deposit of talcum powder entered in enclosure.	Pass

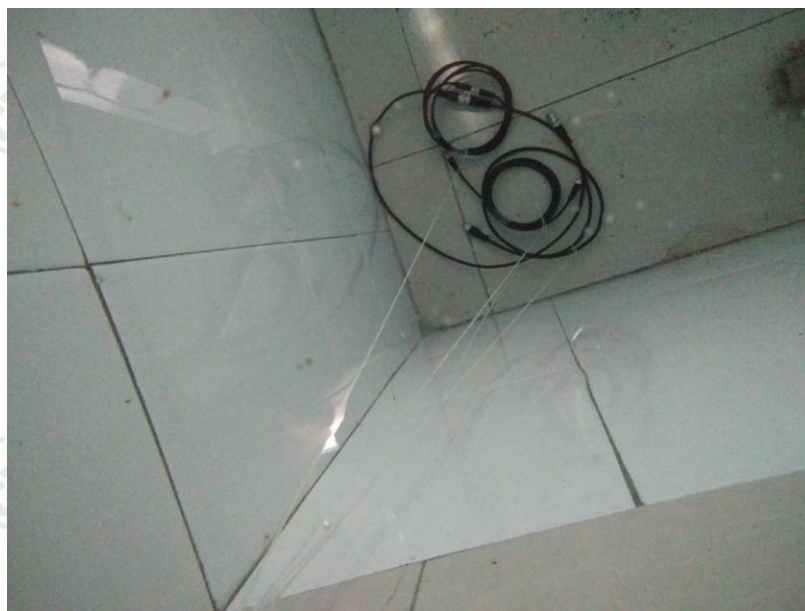
Fig.5- Sample during IPX7 test

- 1) The lowest point of enclosures with a height less than 850 mm is located 1000 mm below the surface of the water.
- 2) The duration of the test is 30 min.
- 3) The water temperature does not differ from that of the equipment by more than 5 K. However, a modified requirement may be specified in the relevant product standard if the tests are to be made when the equipment is energized and/or its parts in motion.

Sample No.	Test time	Observations	Verdict
S161014003-4	30min	After the test, no trace of water entered in enclosure.	Pass

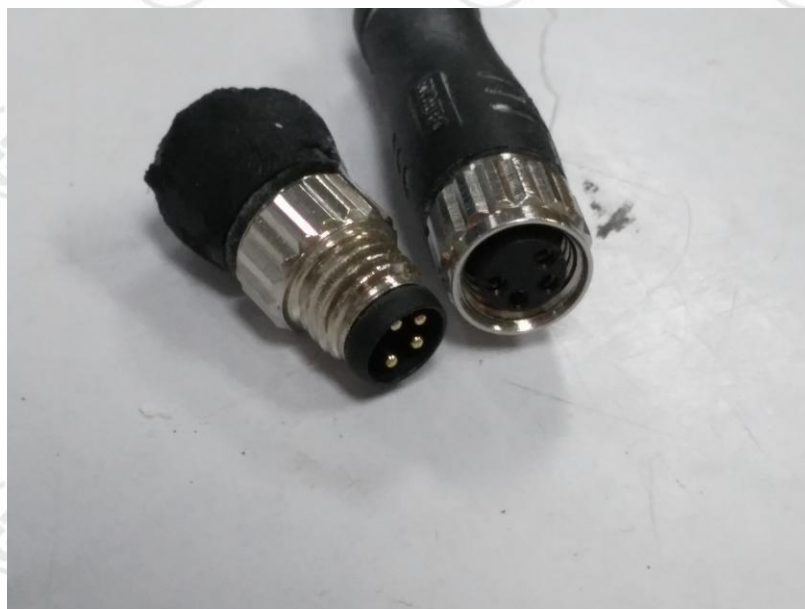
Fig.6- Sample after IP6X test

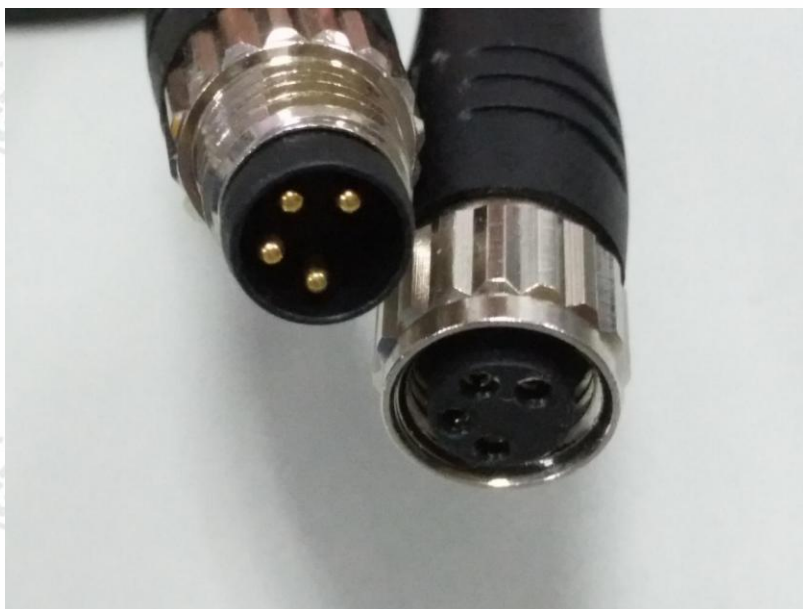
Fig.7- Sample after IPX7 test

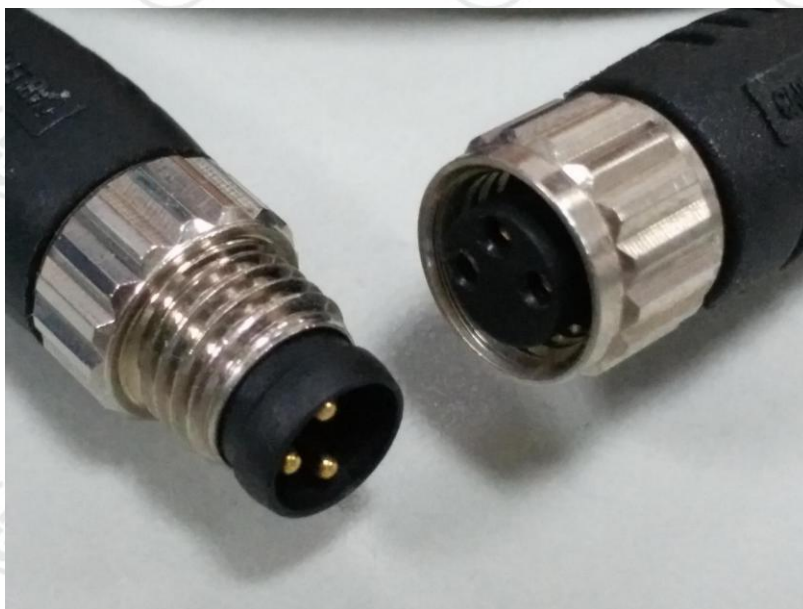
Fig.8- Overall view of model MB03CXXXX series

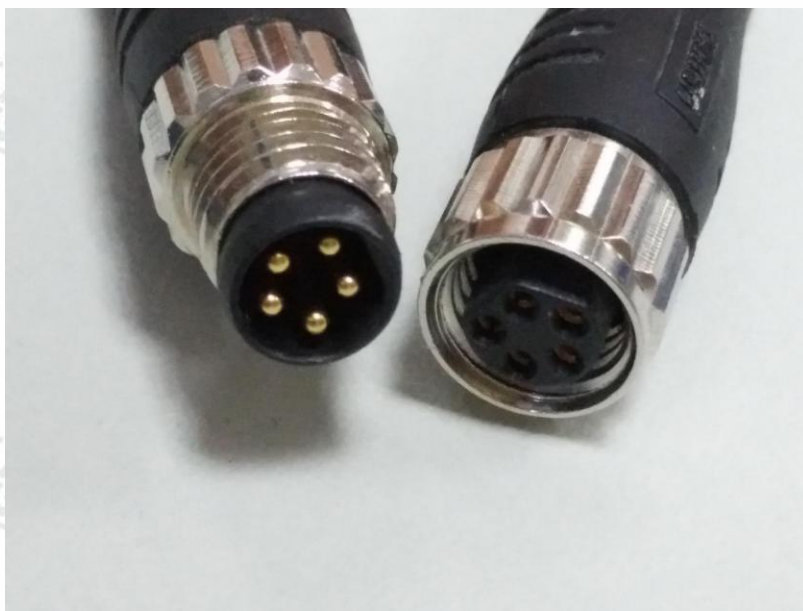
Fig.9- Overall view of model MB05CXXXX series

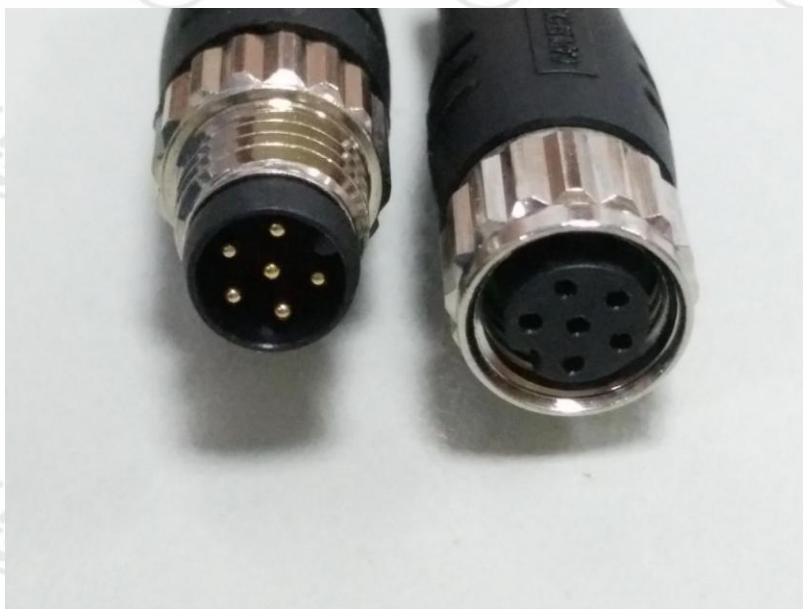
Fig.10- Overall view of model MB06CXXXX series

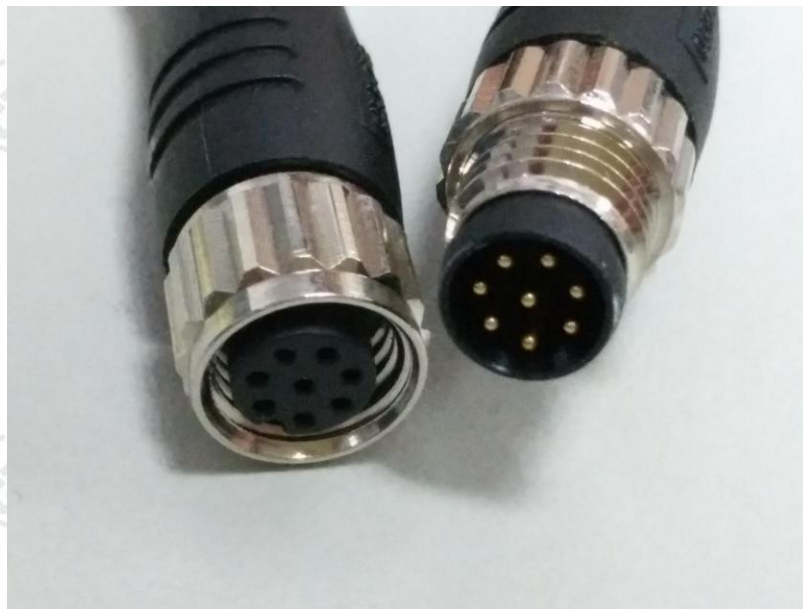
Fig.11- Overall view of model MB08CXXXX series
