Test Report

Report No.: EED31I00484802R1

Sample Name : M12 Circular Connectors and M12 Cable
Model : MC04CXXXX series, MC03CXXXX series, MC05CXXXX series, MC08CXXXX series, MC12CXXXX series
Trade : Cableforce
Test Item : IP67
Surrounding : 24°C, 61% R.H.
State of Sample(s) : Normal
Sample Quantity : 1 pc
Manufacture : Cableforce Electronics Company Limited

Sample Received Date : Oct. 17, 2016
Sample tested Date : Oct. 19, 2016
Test Requested : 1) IEC 60529:2013;
2) According to client's request.

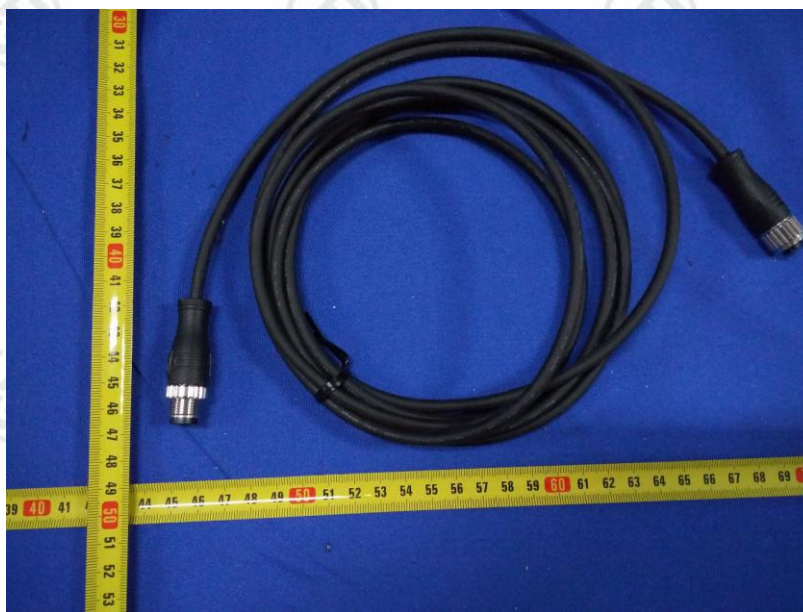
Fig.1- Overall view of model MC04C3LSG3ASB

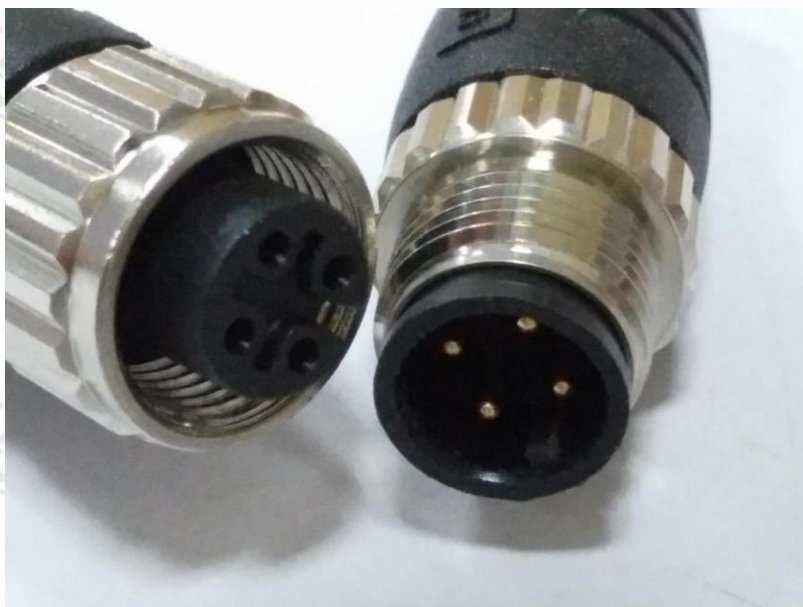
Fig.2- Overall view of model MC04C3LSG3ASB

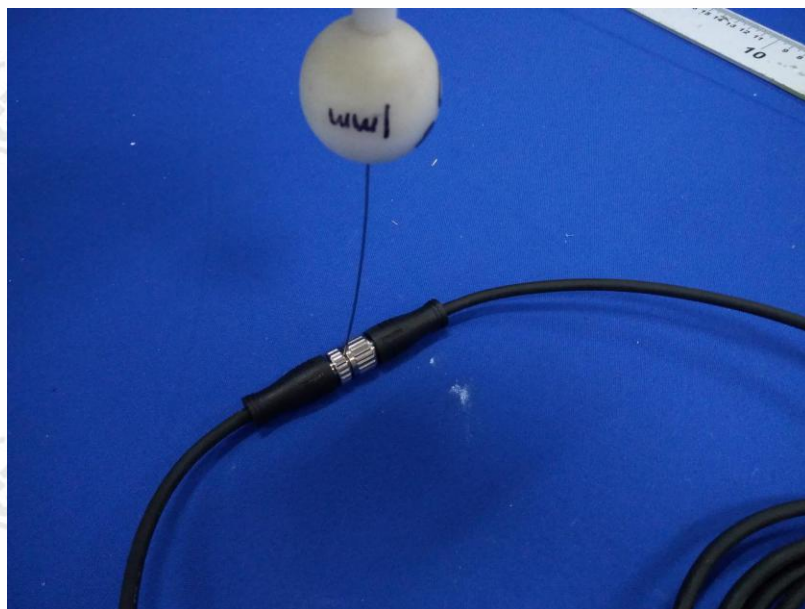
Fig.3- Sample during IP6X test(using test wire of 1.0mm Φ)

- 1) The test wire of 1.0mm Φ shall not penetrate and adequate clearance shall be kept.
- 2) The test is made using a dust chamber, the powder circulation pump may be replaced by other means suitable to maintain the talcum powder in suspension in a closed test chamber. The talcum powder used shall be able to pass through a square-meshed sieve the nominal wire diameter of which is 50 μm and the nominal width of a gap between wires 75 μm . The amount of talcum powder to be used is 2 Kg per cubic meter of the test chamber volume. It shall not have used for more than 20 tests.
- 3) If an extraction rate of 40 to 60 volumes per hour is obtained the duration of the test is 2 h.
- 4) If, with a maximum depression of 2 kPa(20 mbar), the extraction rate is less than 40 volumes per hour, the test is continued until 80 volumes have been drawn through, or a period of 8 h has elapsed.

Sample No.	Test time	Observations	Verdict
S161014003-2	2h	The test wire did not penetrate the specimens, and adequate clearance was kept. After test, no deposit of talcum powder entered in enclosure.	Pass

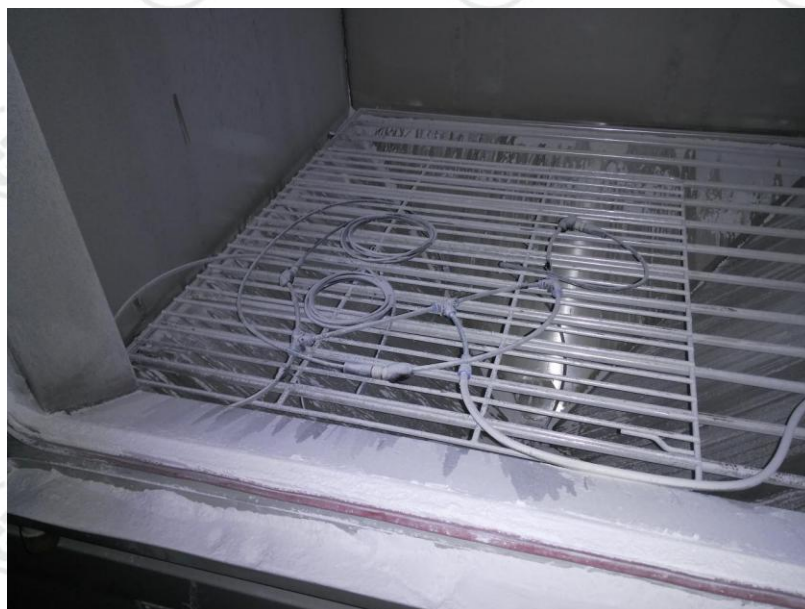
Fig.4- Sample during IP6X test

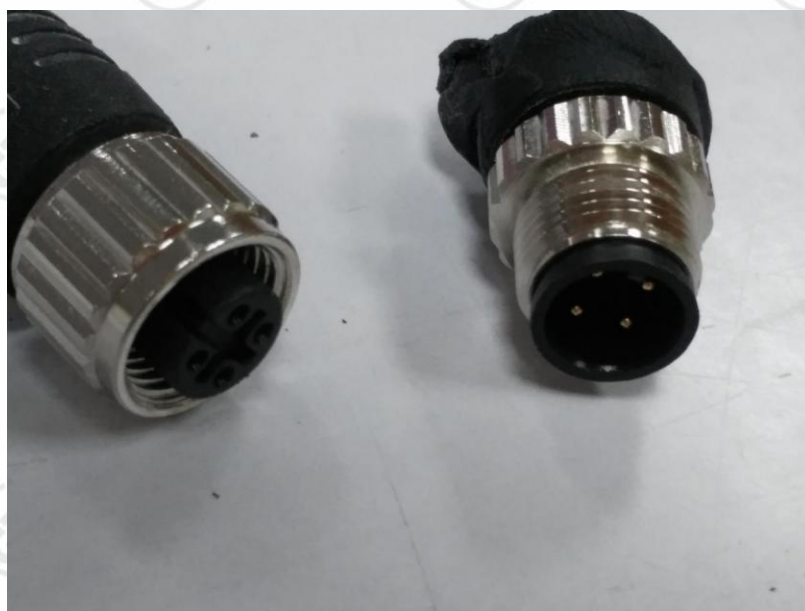
Fig.6- Sample after IP6X test

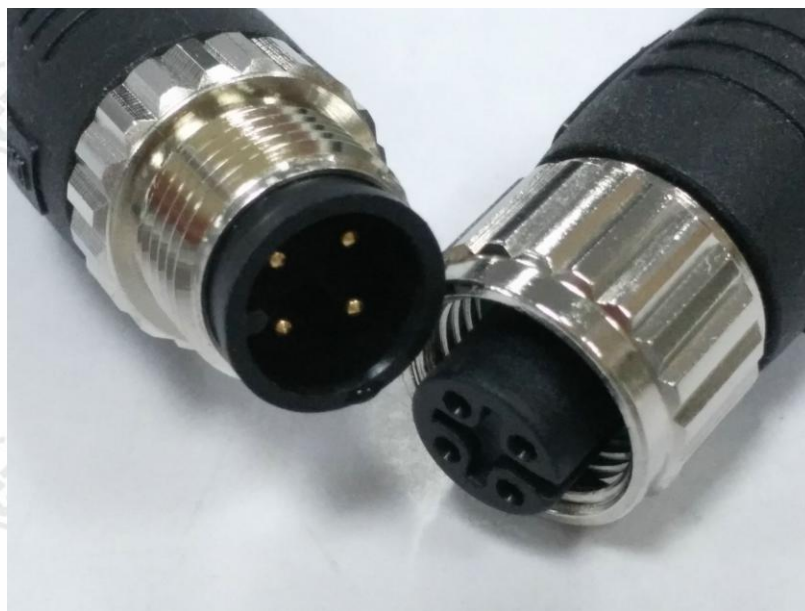
Fig.7- Sample after IPX7 test

Sample No.	Test time	Observations	Verdict
S161014003-2	30min	After the test, no trace of water entered in enclosure.	Pass

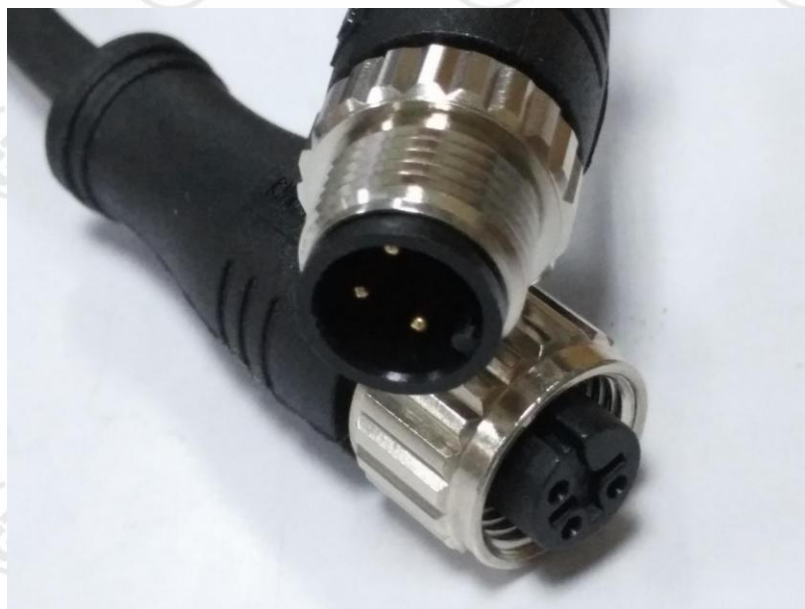
Fig.8- Overall view of model MC03CXXXX series

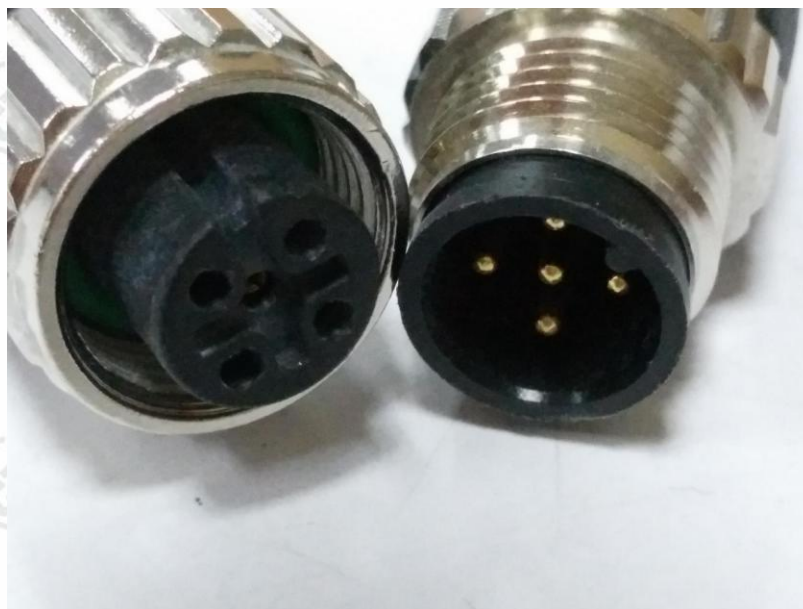
Fig.9- Overall view of model MC05CXXXX series

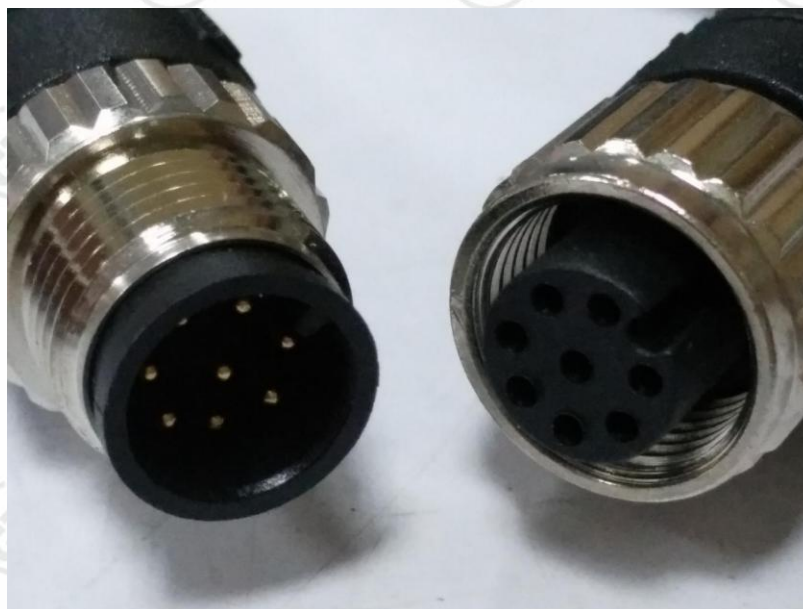
Fig.10- Overall view of model MC08CXXXX series

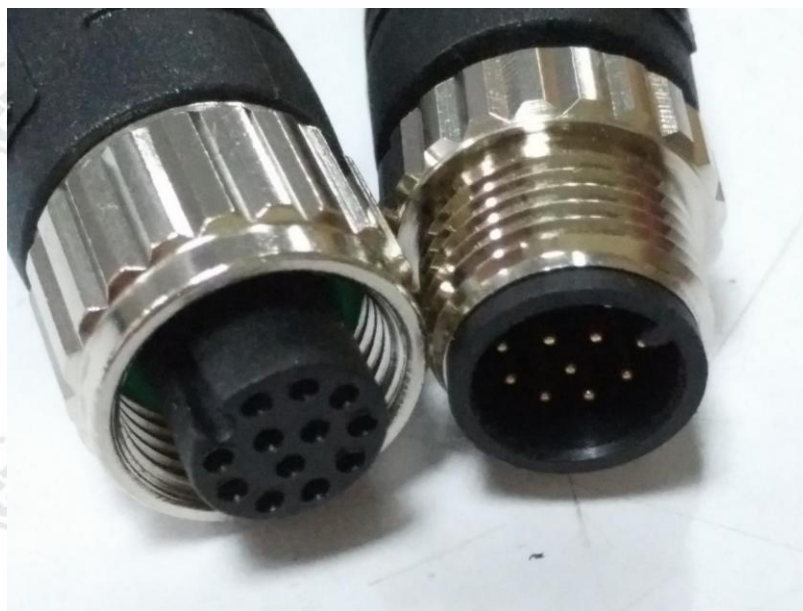
Fig.11- Overall view of model MC12CXXXX series
